# LIVESTOCK AND VEHICULAR UNDERPASSES IN USE

LIVESTOCK AND VEHICULAR UNDERPASSES IN USE --photographic illustrations

RIGHT-OF-WAY SECTION

STATE OF MONTANA - DEPARTMENT OF HIGHWAYS

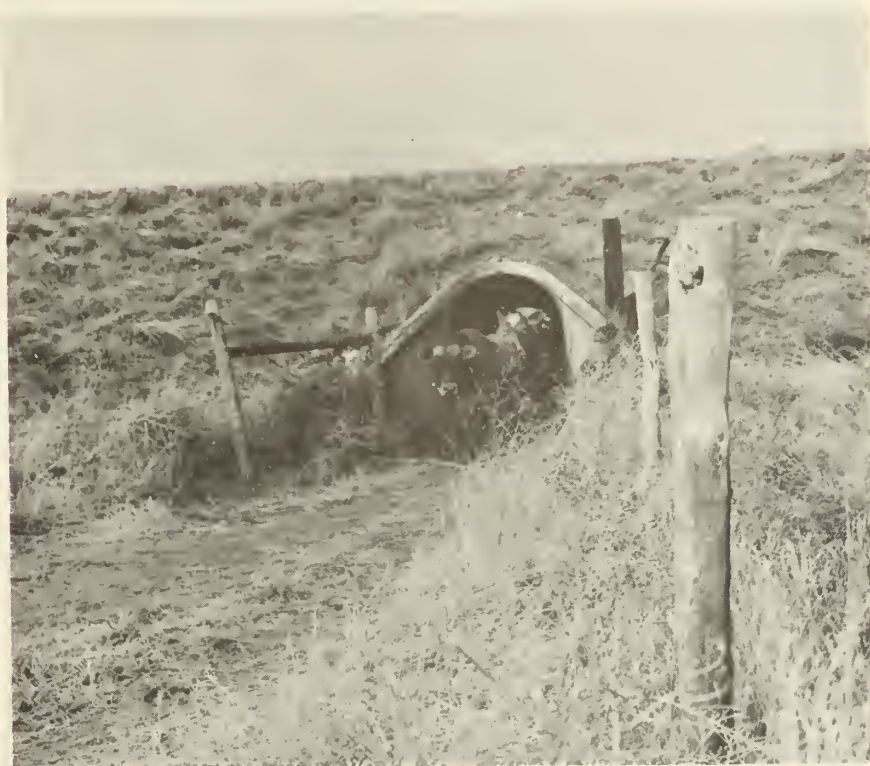
East Exit

4's x 6'r x 35' long, Concrete Arch S.P., Std. Drg. 63-01. Two miles south of Whitehall. Holstein, Guernsey, Dutch Belton dairy cows, totaling 34 head. Herd was moved to east of highway and back again.

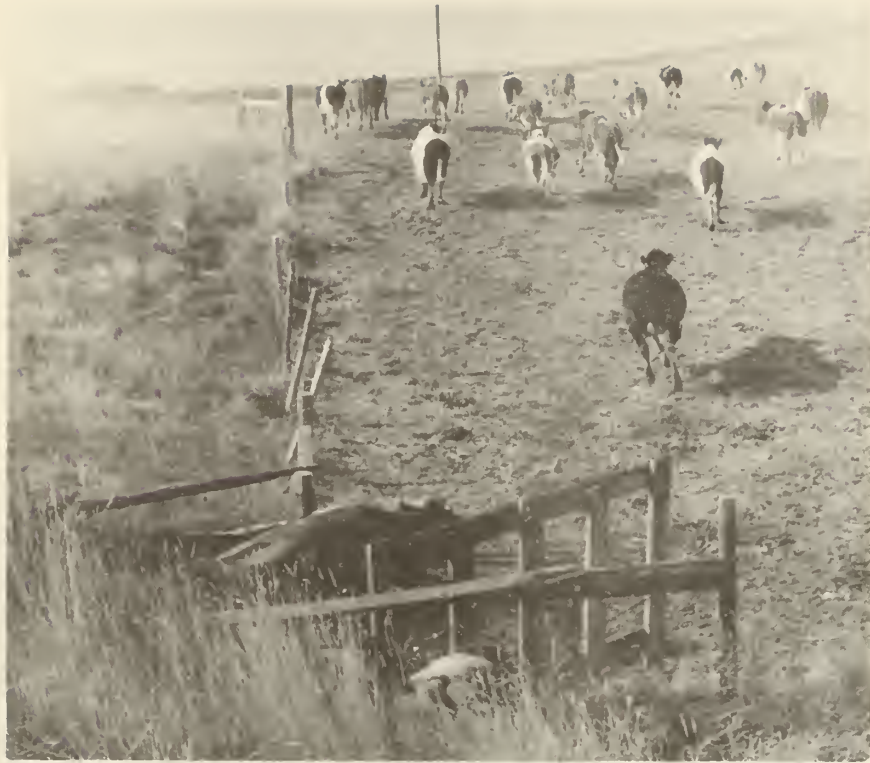
West Exit

4's x 6'r x 35' long, Concrete Arch S.P., Std. Drg. 63-01. Two miles south of Whitehall. Holstein, Guernsey, Dutch Belton dairy cows, totaling 34 head. Cattle did not hesitate except when cameraman stood in front over entrance.

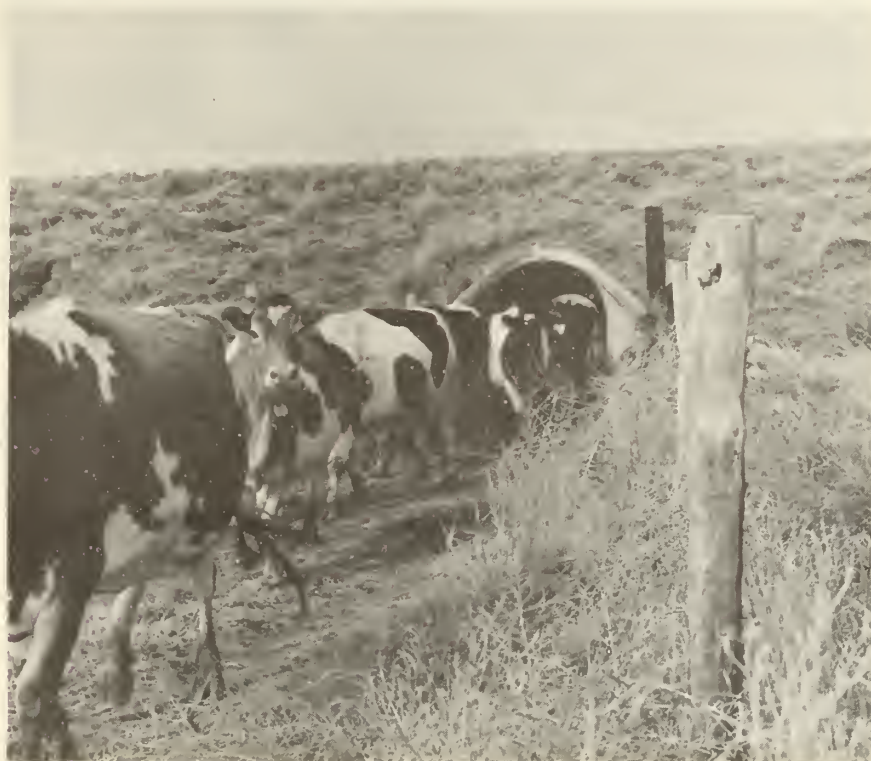
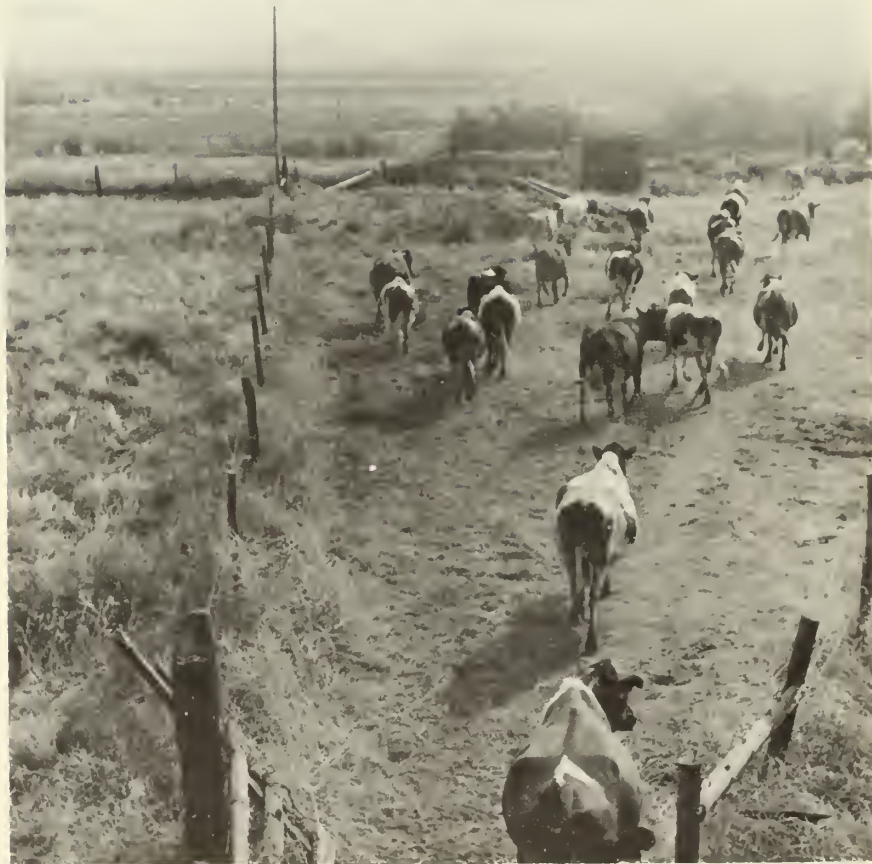
East Exit

4's x 6'r x 35' long, Concrete Arch S.P., Std. Drg. 63-01. Two miles south of Whitehall. Holstein, Guernsey, Dutch Belton dairy cows, totaling 34 head. Notice how the cattle watch the cameraman. They seem a bit uneasy around strangers.

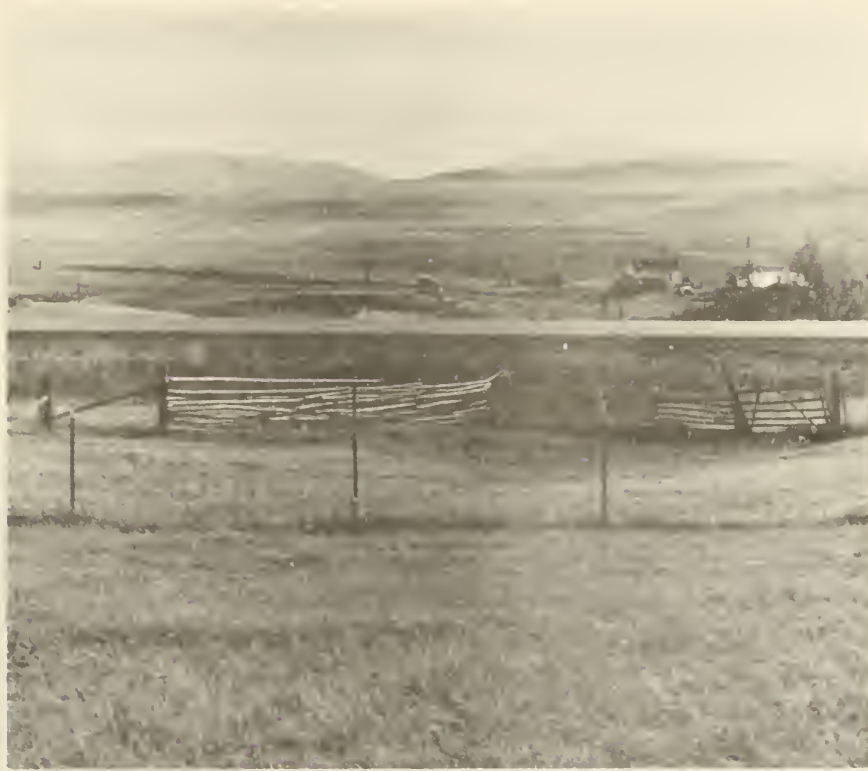
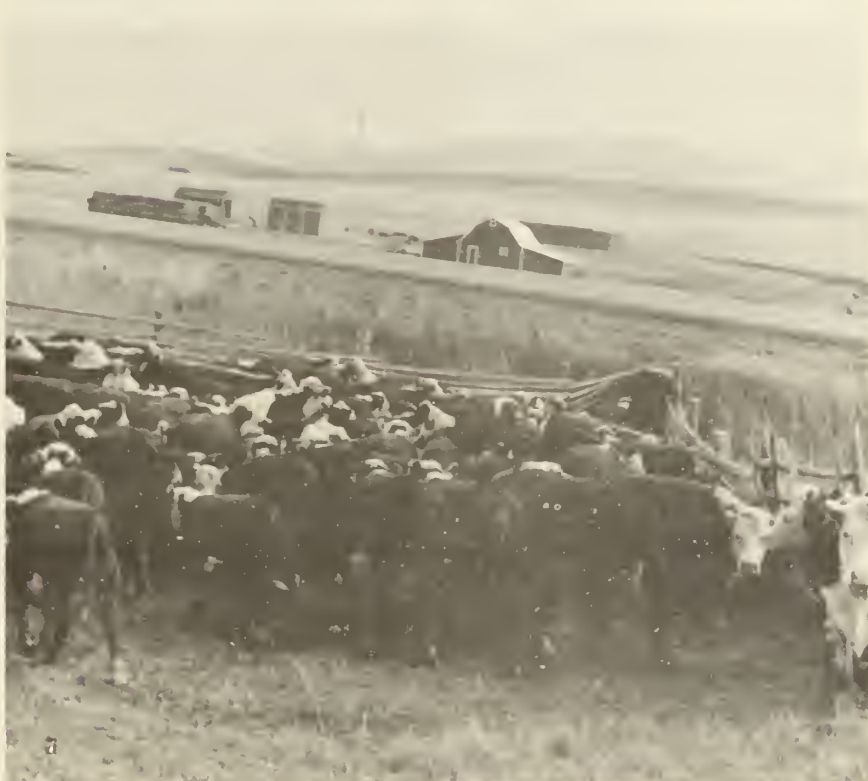
North Entrance

5'10"s x 6'6"r x 76' long, Arch C.M.P., Type 'A', Std. Drg. 59-02. About 4 miles east of Raynesford on 2-lane Highway #87. Herd movement of 250 head into corral and through stockpass. Time to move them across was about 30 minutes.

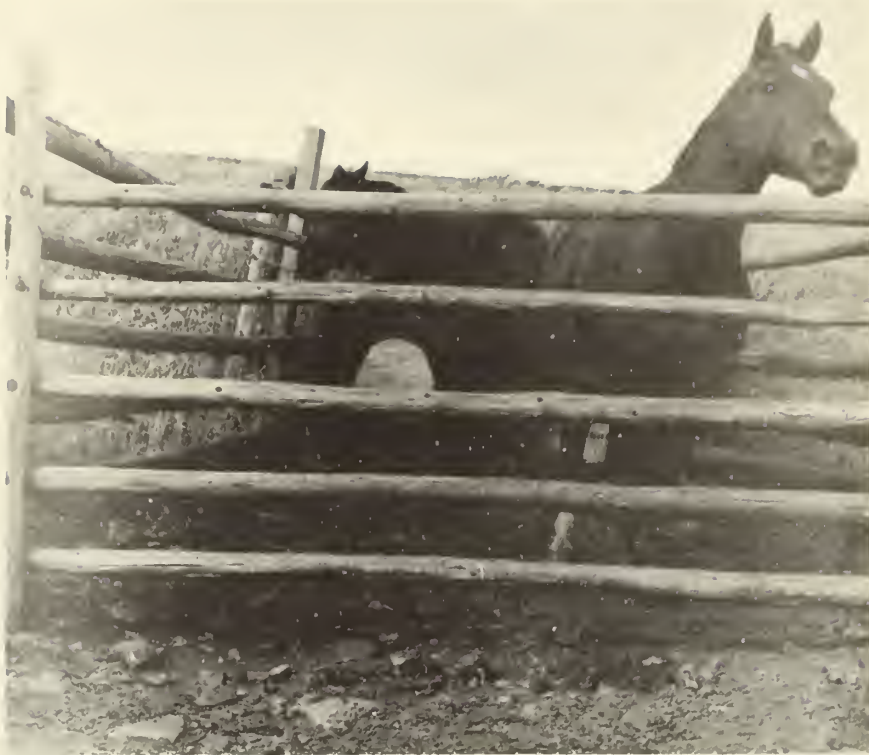
South Exit

5'10''s x 6'6''r x 76' long, Arch C.M.P., Type 'A', Std. Drg. 59-02. Horses did not hesitate to go through; gate was then opened for 250 head of cattle from north holding corral.

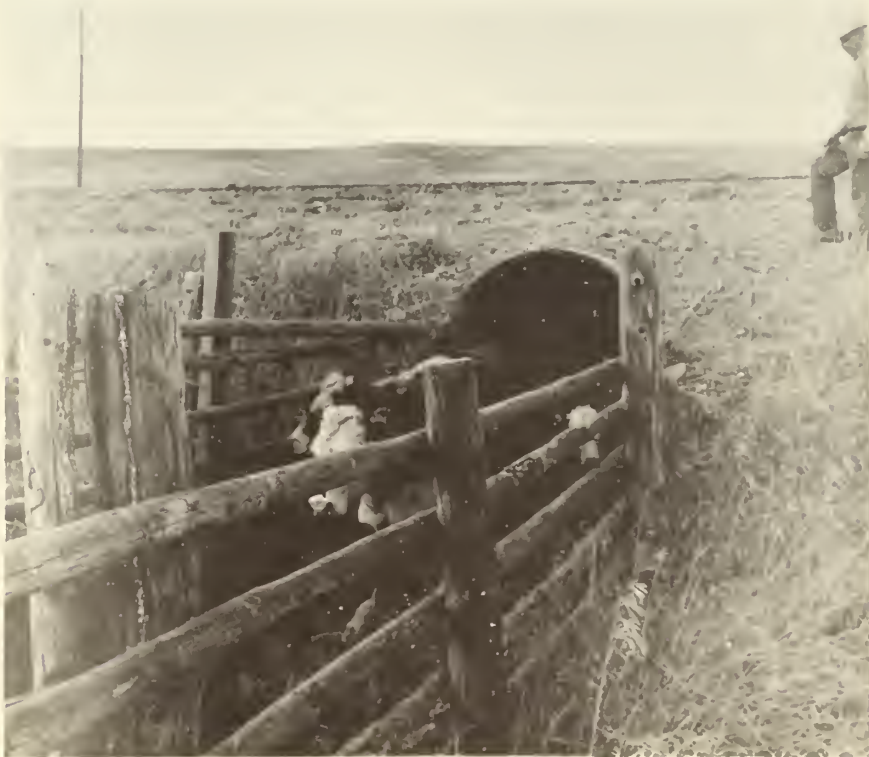
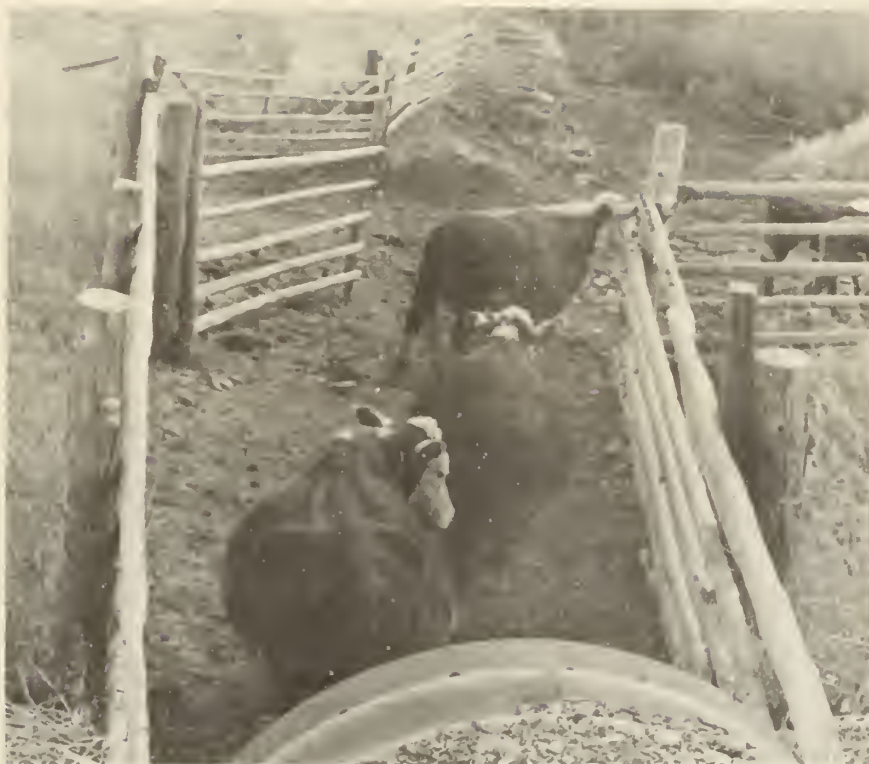
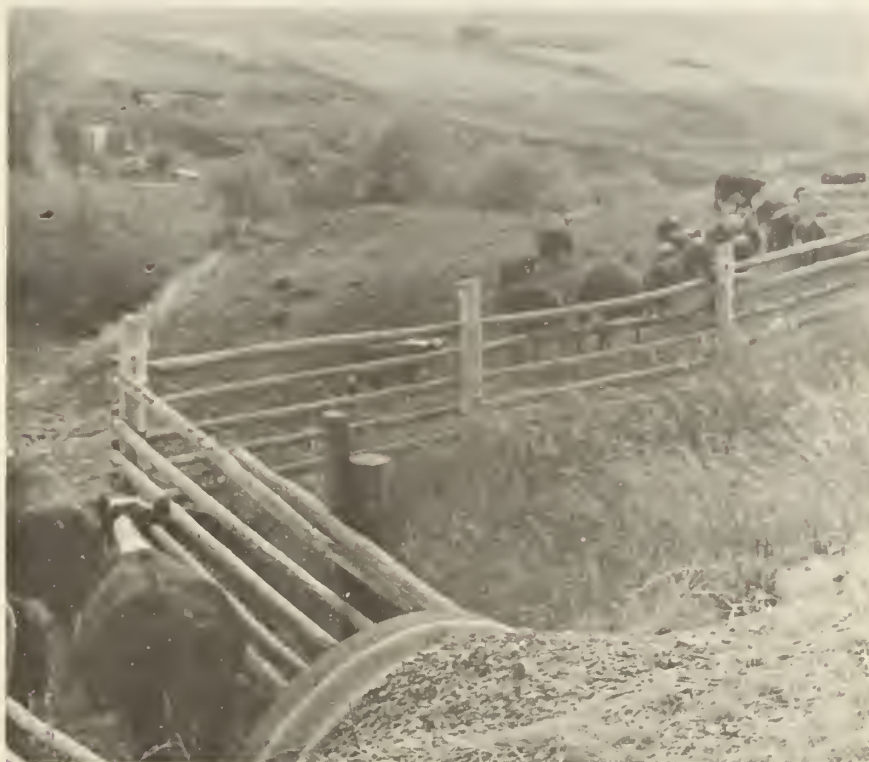
South Exit

5'10"s x 6'6"r x 76' long, Arch C.M.P., Type "A", Std. Drg. 59-02. Herd of 250 head moving through to south pastures for further stock drive the following day. Total crossing time about 30 minutes. Poles are much easier on cattle in these tight situations than barbed wire.

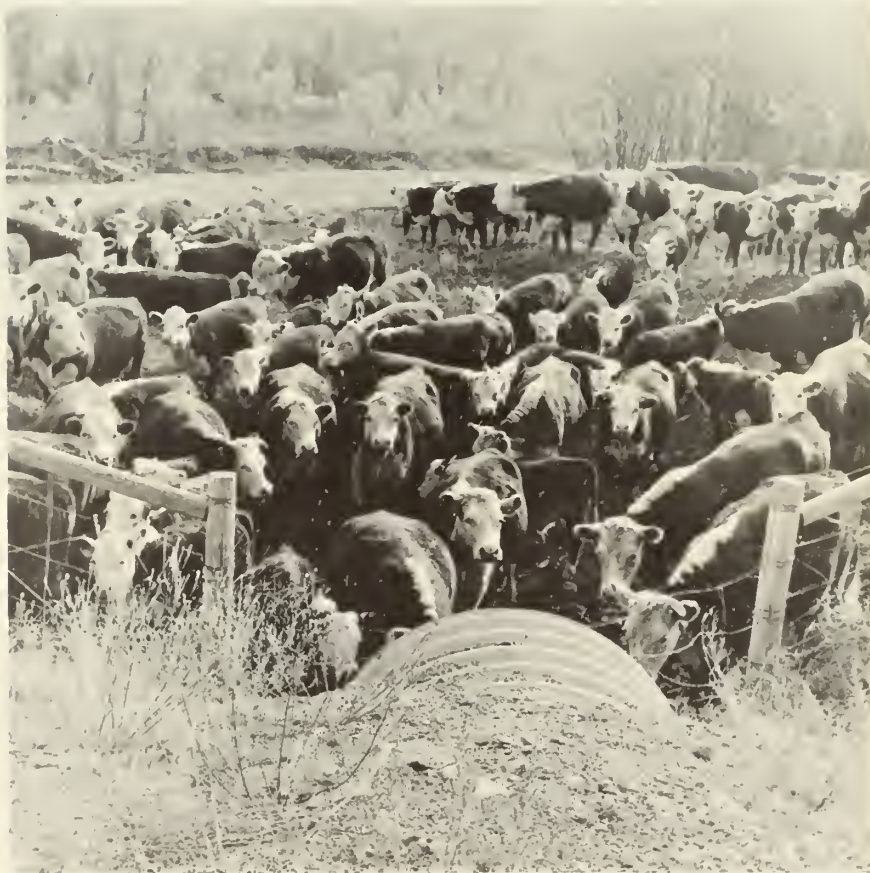
East Entrance

5'10" x 7'7" x 88' long, Arch C.M.P., Type "B", Std. Drg. 59-02. No holding pens, gradual wing fencing into recessed (bottom) location. Cattle were a little hesitant when cameraman stood on the shoulder in front of them. About 3-3/4 miles southeast of Belt, near Armington Junction on U.S. #89.

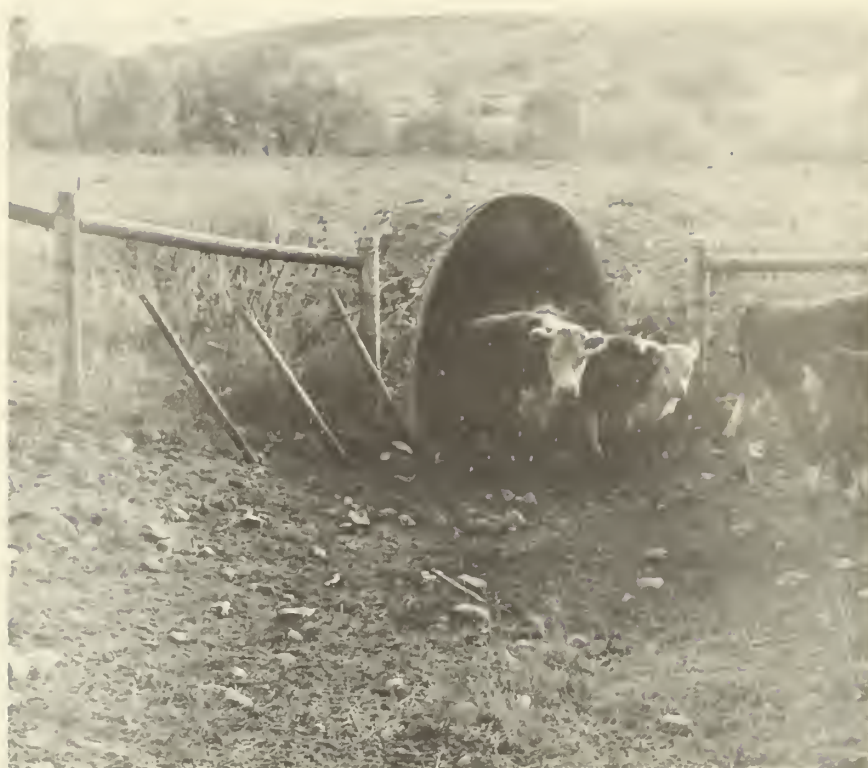
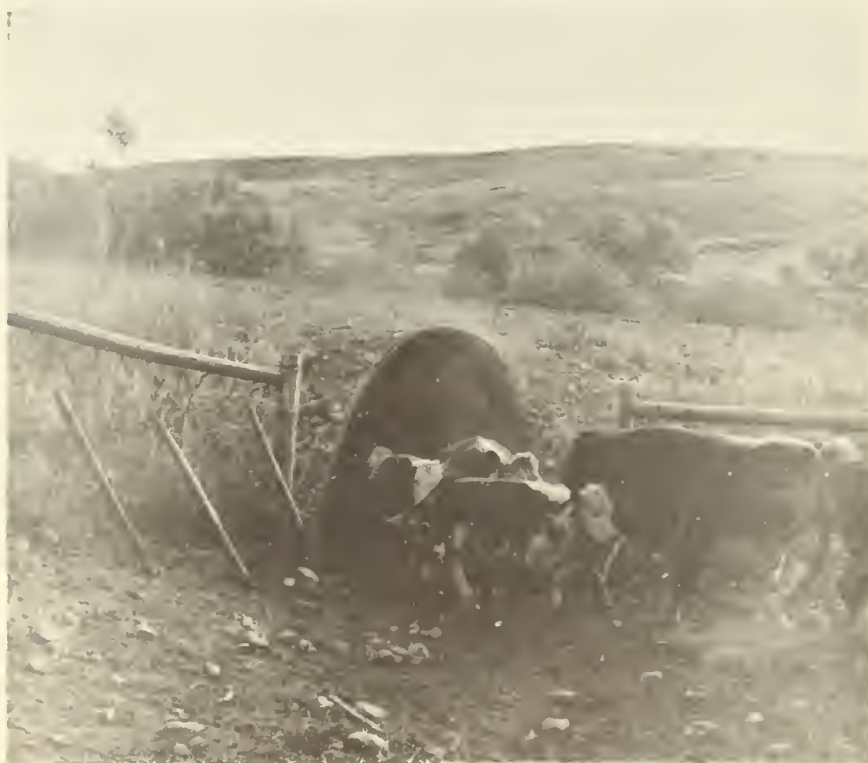
West Exit

5'10''s x 7'7''r x 88' long, Arch, C.M.P., Type 'B', Std. Drg. 59-02. Herd did not stop as long as cameraman gave them room enough to move. Movement was steady, about 20 minutes crossing time.

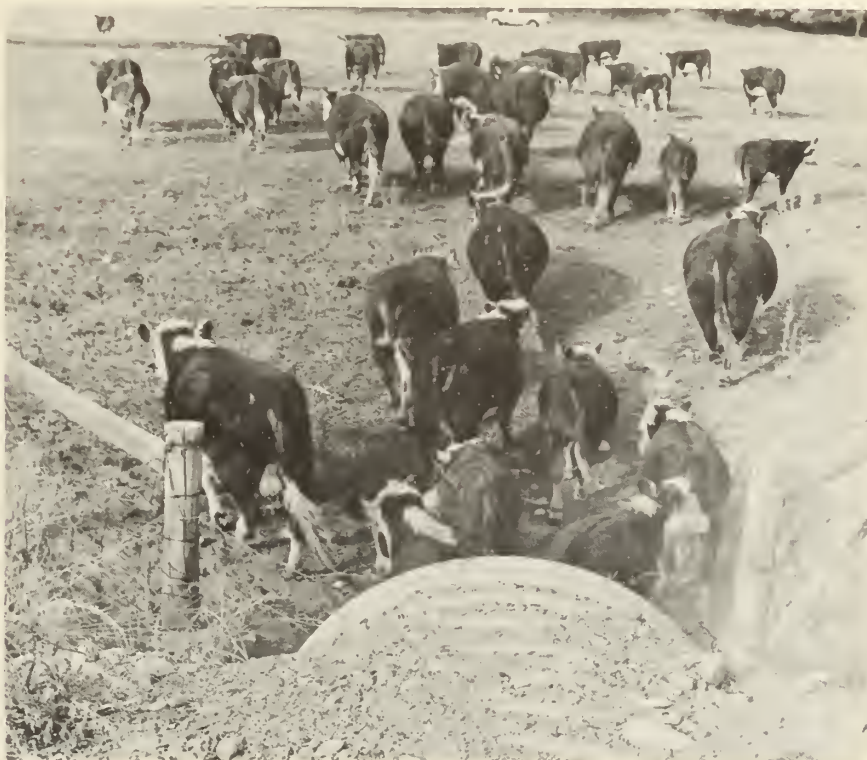
West Exit to Meadows

5'10" x 7'7" x 88' long, Arch C.M.P., Type "B", Std. Drg. 59-02. Steady herd movement across meadow to upper pastures. Notice wire tied to stockpass. These cattle were quite familiar with this stockpass; second season in use.

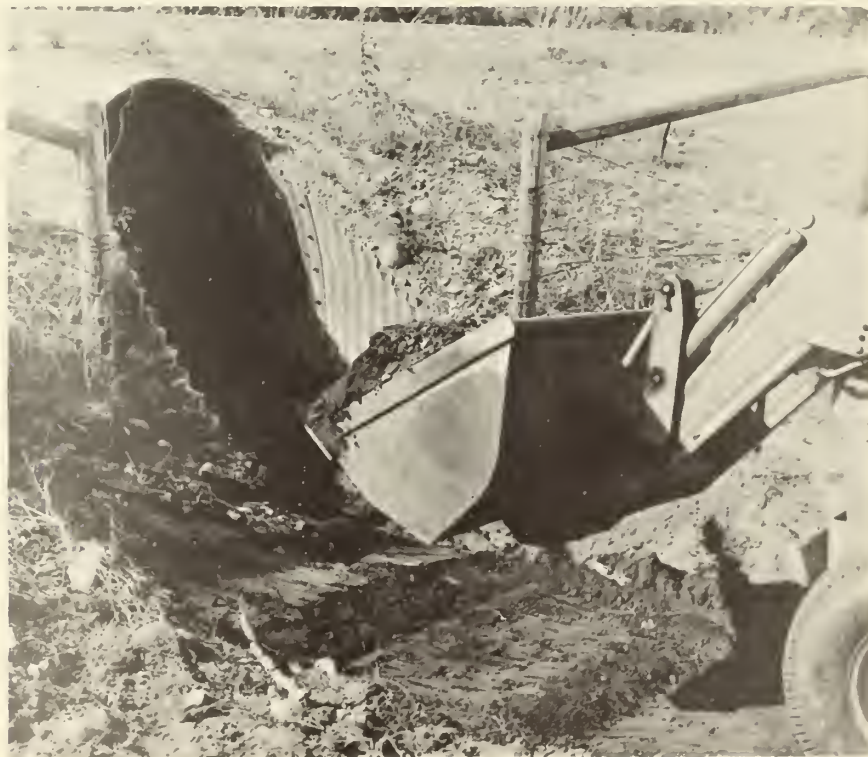
East Entrance

5'10"s x 7'7"r x 88' long, Arch C.M.P., Type "B", Std. Drg. 59-02. No holding pens, gradual wing fencing into recessed (bottom) location. Cattle sluff dirt into bottom, filling east entrance in about 1' in two seasons' use. See Page 14 for cleaning procedure. This stockpass, in spite of this and early season drainage, has very high utility. Just south of the Armington Junction, 3-3/4 miles southeast of Belt on U.S. #89.

5'10"s x 7'7"r x 88' long, Arch C.M.P., Type "B", Std. Drg. 59-02. Highway employees are using a backhoe front-end loader to remove dirt filled in by herd movement into stockpass, at request of landowner.

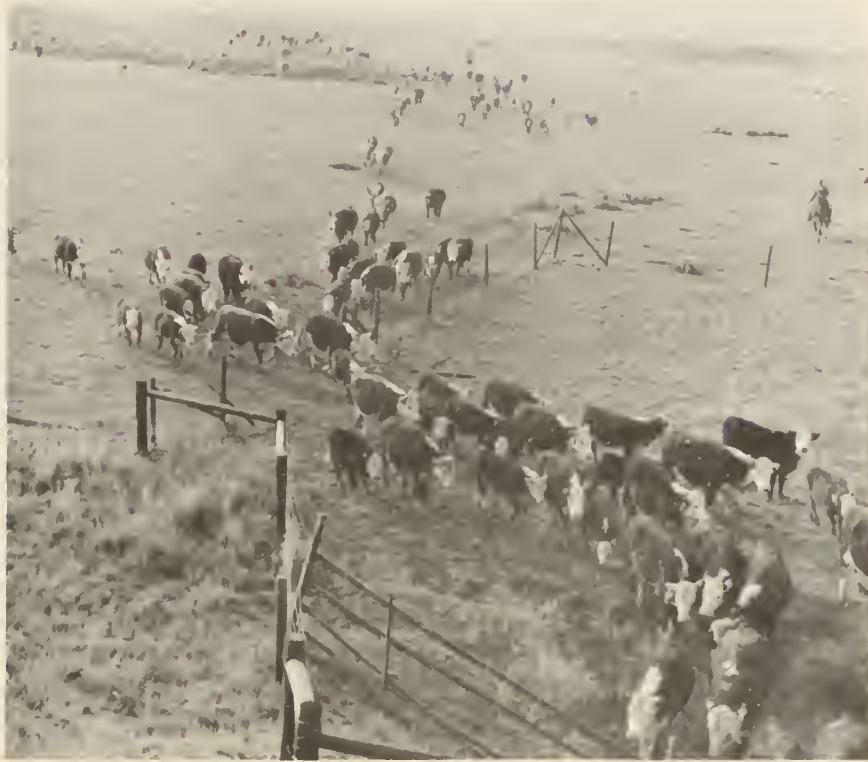
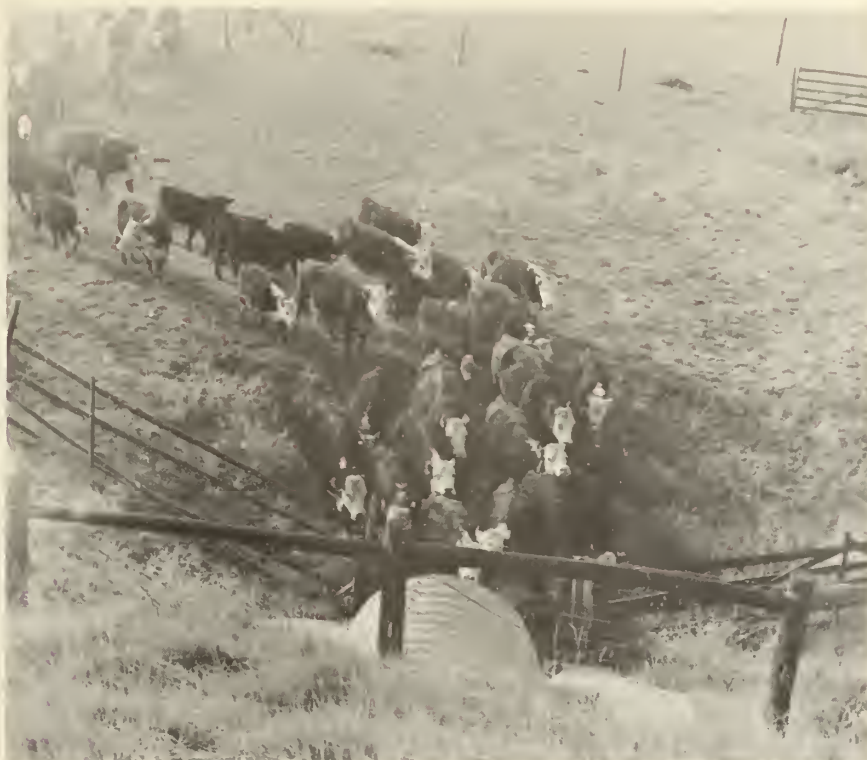
South Entrance

6'11" x 8'6" x 262' long, Arch C.M.P., Design #99, old Std. Drg. 59-04. About 200 head mixed herd movement from south to north. These stock were reasonably familiar with this underpass and stock trail. Notice stock holding pen--no longer necessary says owner.

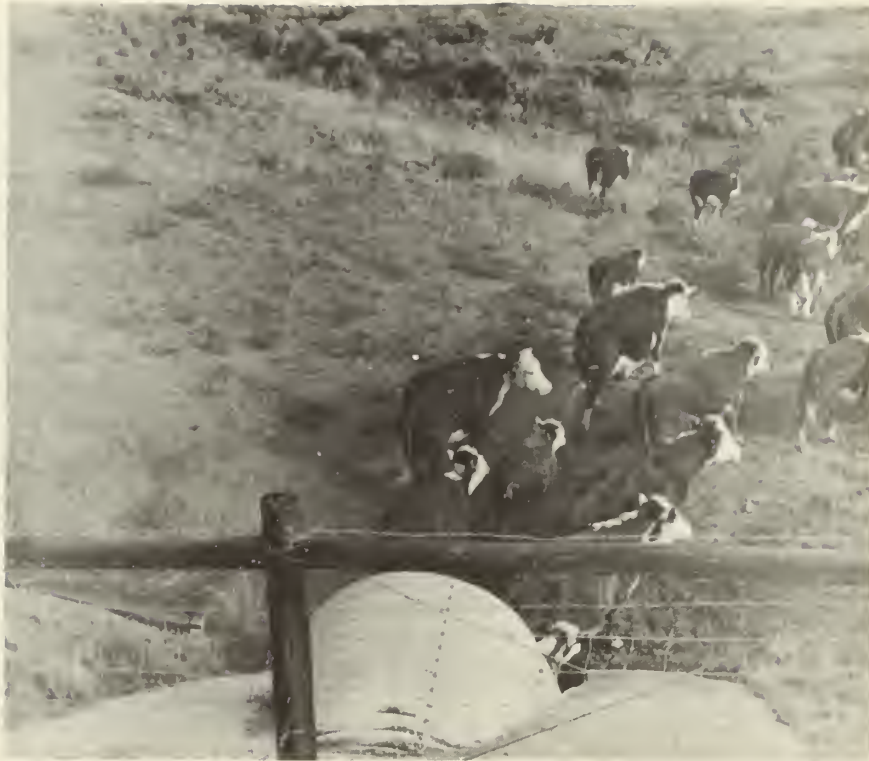
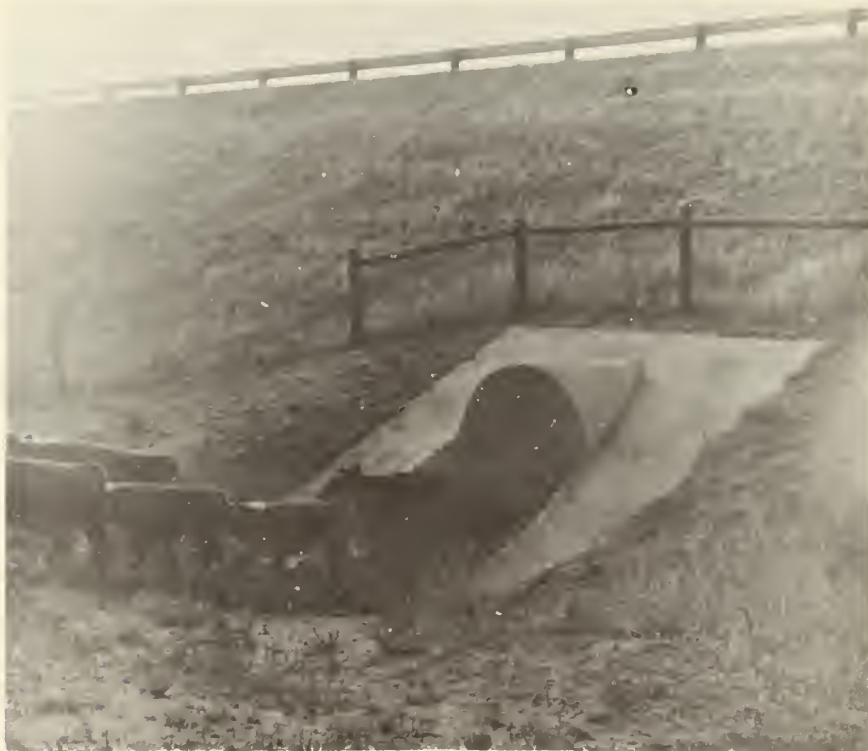
North Exit

6'11"s x 8'6"r x 262' long, Arch C.M.P., Design #99, old Std. Drg. 59-04. About 200 head herd movement from south to north and return. Rancher, two sons and daughter moved cattle. Three miles west of Whitehall near Pipestone Interchange. Less than one hour to move them through and back again.

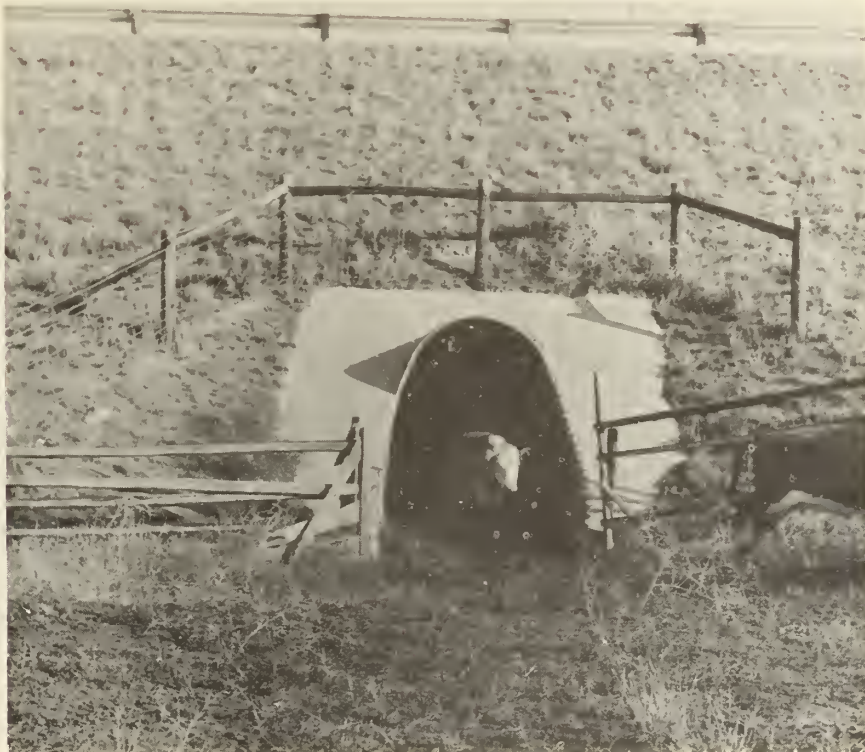
South Exit

6'11" x 8'6" x 262' long, Arch C.M.P., Design #99, old Std. Drgs. Herd of 200 head returning through pipe. This structure will handle three abreast. Notice there are no wires tied into structure. Cattle can climb up on wing wall, which can be injurious to cattle.

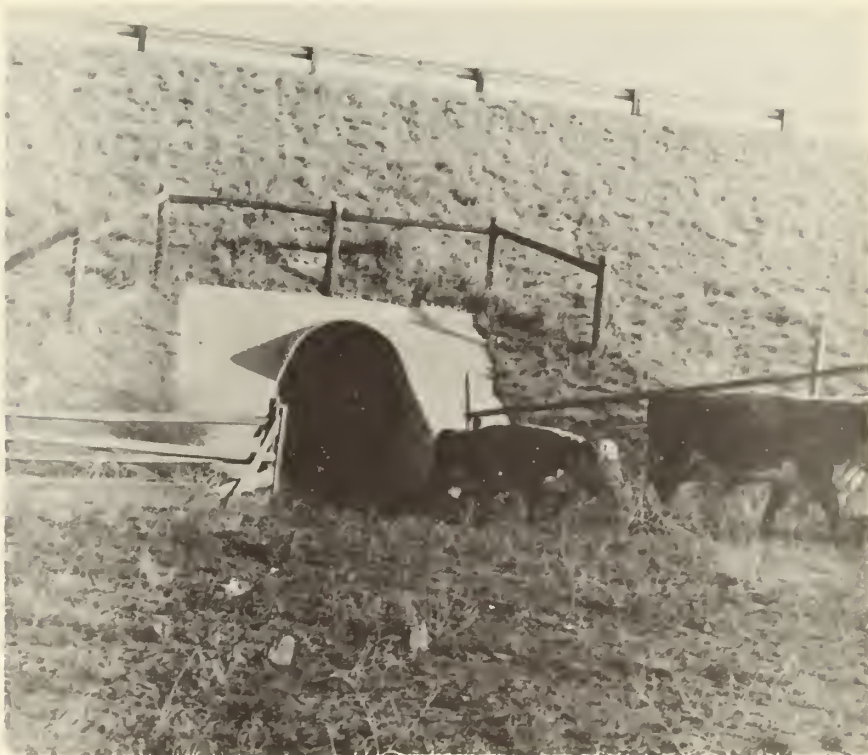
South Exit

6'11"s x 8'6"r x 262' long, Arch C.M.P., Design #99, old Std. Drgs. Continuing photos of 200 head herd movement north to south. Fencing should not be above stockpass, but tied into it. However, this underpass has high utility for stock movement.

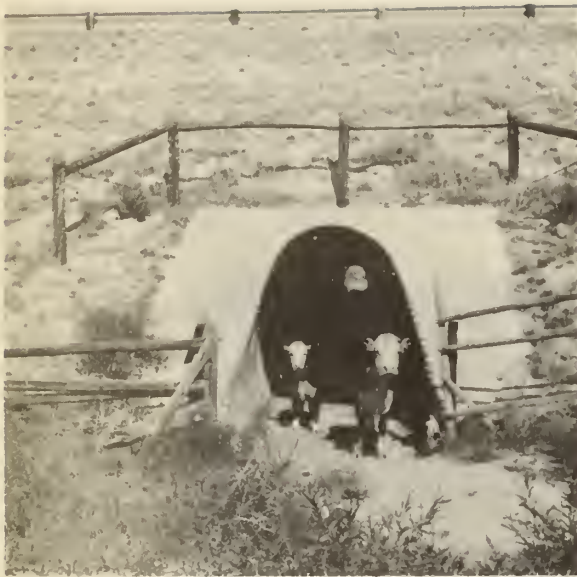
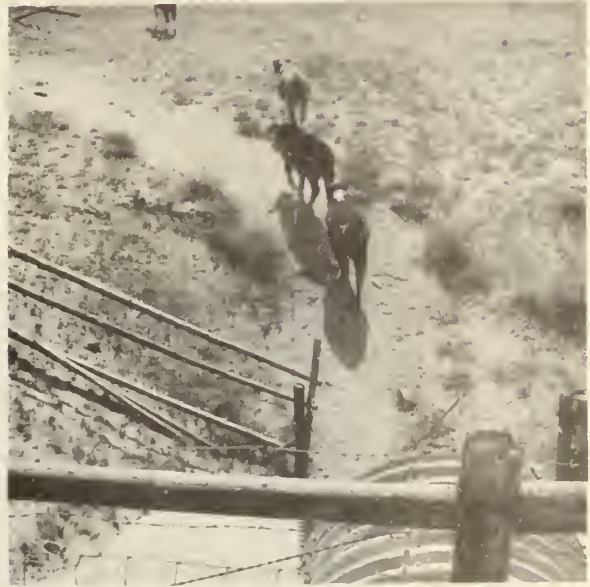
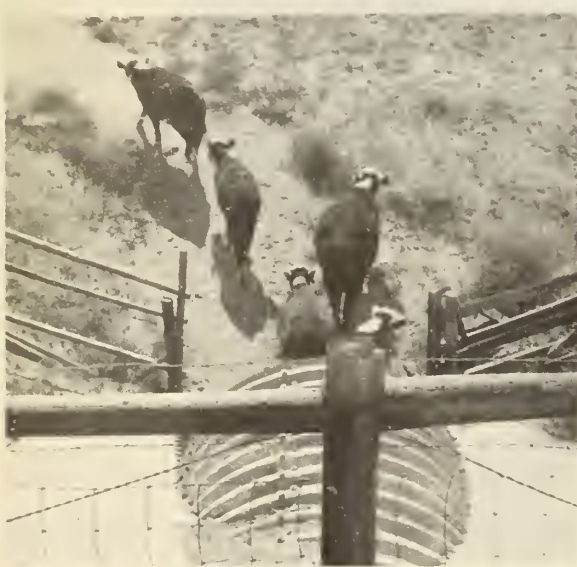
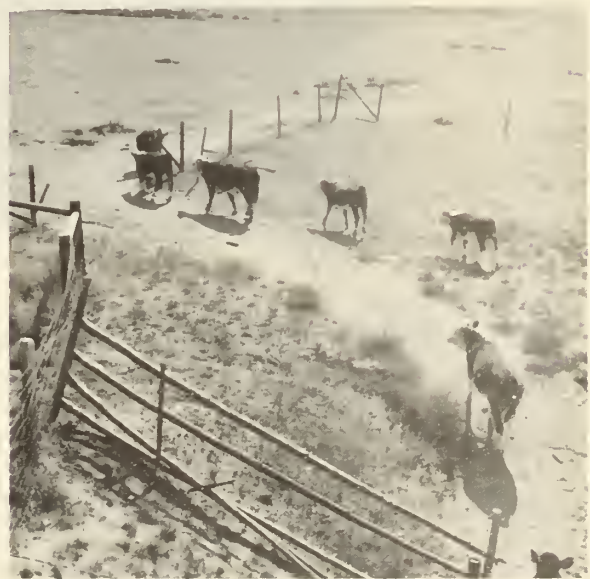
6'11" s x 8'6" r x 262' long, Arch C.M.P. Twenty head of cattle coming in from summer pasture; free herd movement, no riders pushing them.

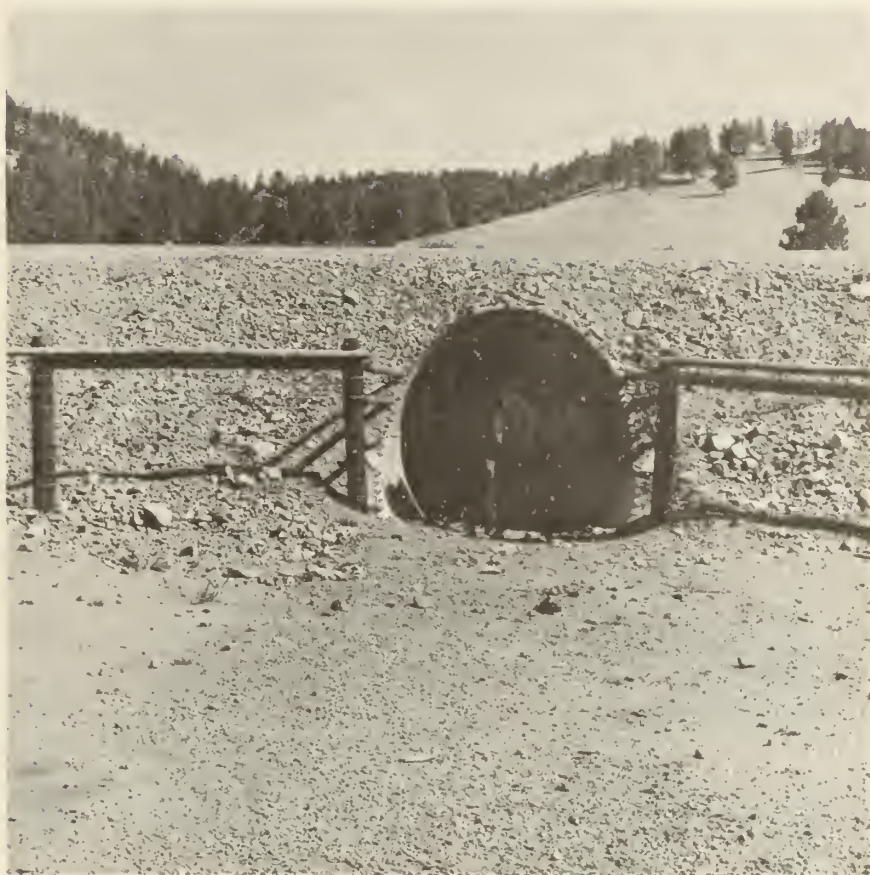
West Exit

108" diameter x 260' long, C.M.P. Near Jefferson City, under 4-lane I-15.  
Seven head of Quarterhorses were herded through this pipe, no hesitation.

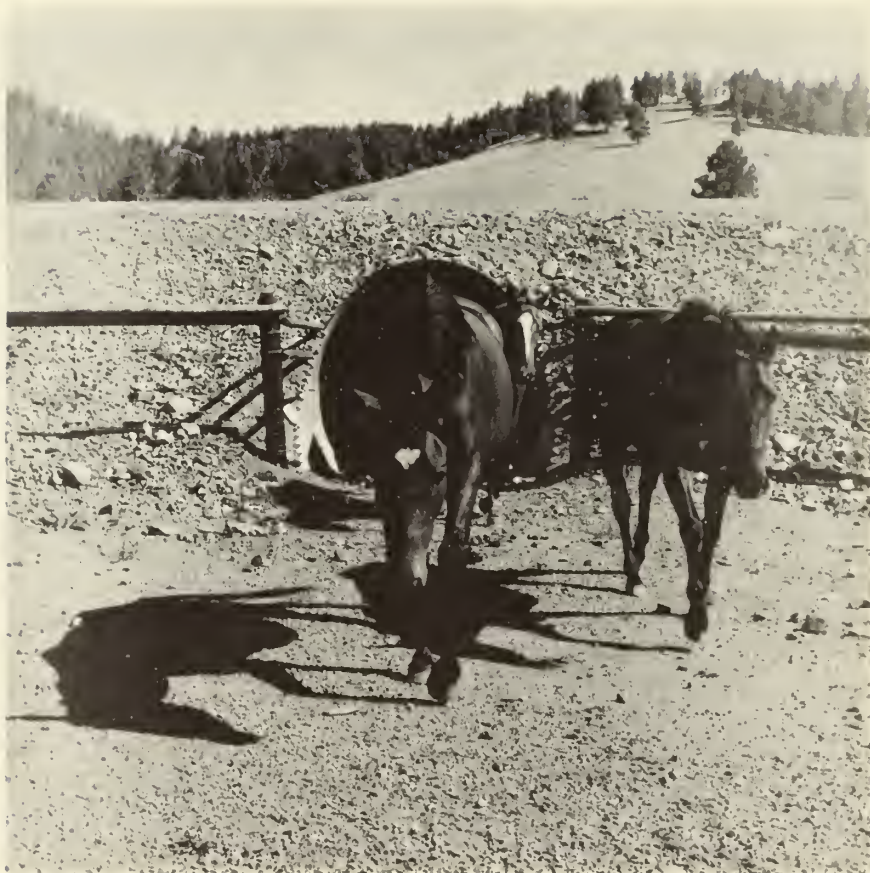
West Exit

108" diameter x 260' long, C.M.P. Near Jefferson City; continuing photos of seven head of Quarterhorses herded through. Horses seem to keep their heads down naturally in this size pipe.

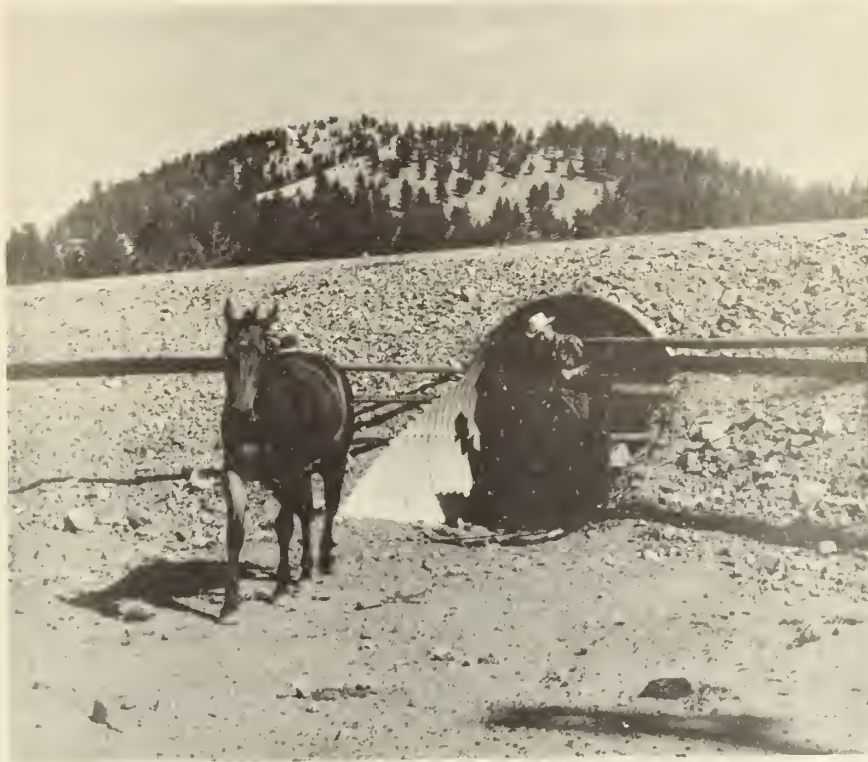
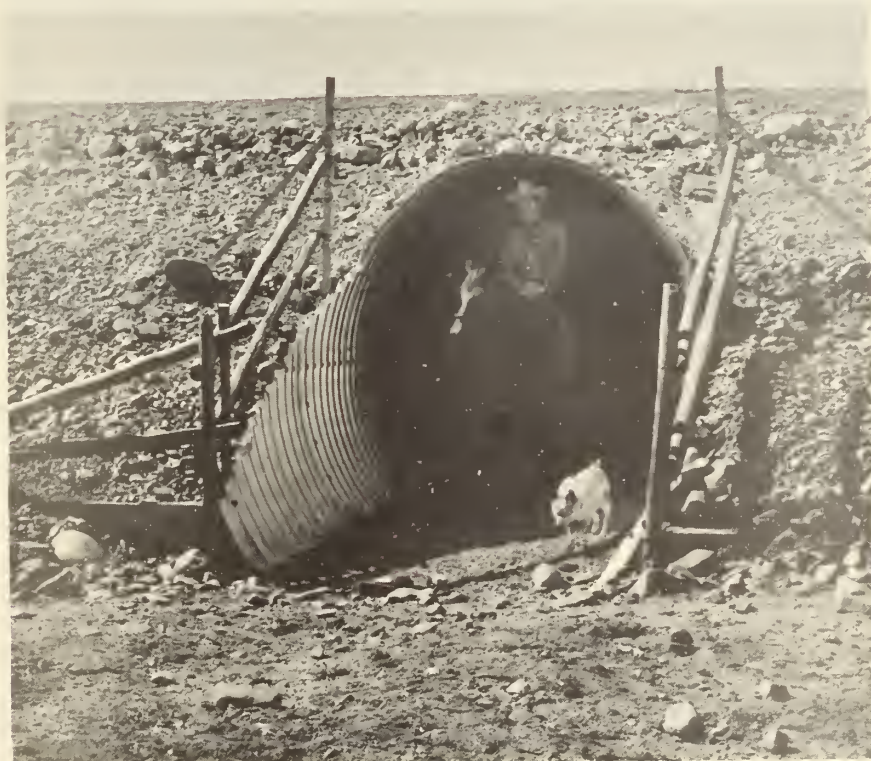
West End

108" diameter x 260' long, C.M.P. Near Jefferson City; 7 head of Quarter-horses herded through, rider was photographed at both ends. He rides his horse through but keeps his head down. Good utility once the horses became used to it.

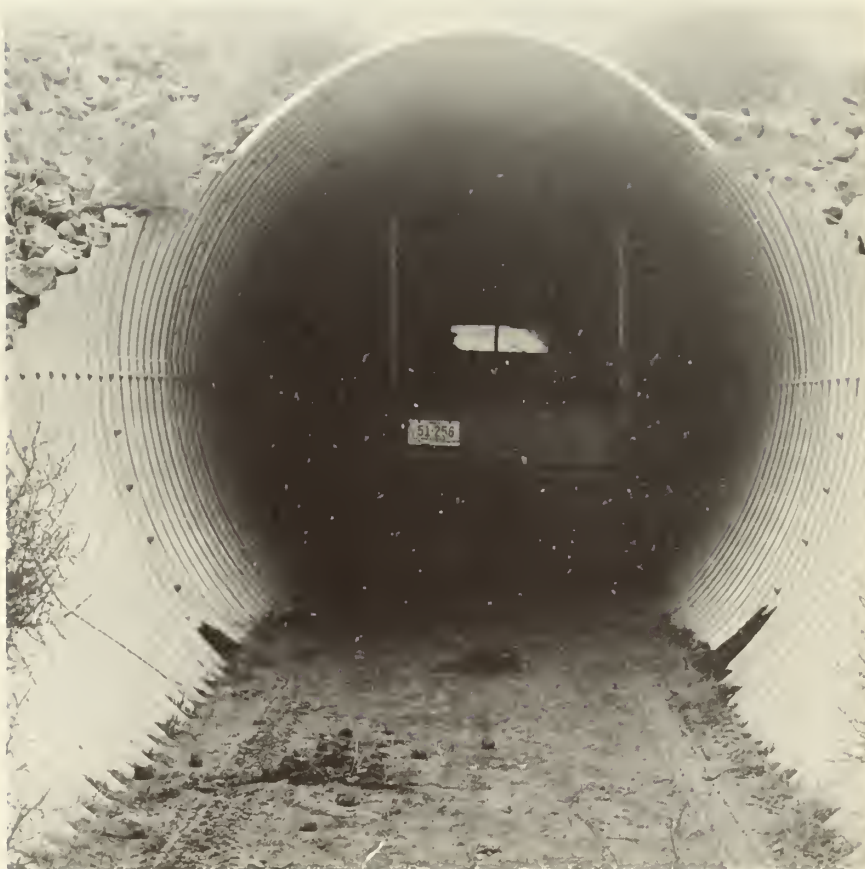
South Entrance Looking North

120" diameter x 100' long, C.M.P. Eight miles west of Three Forks on old U.S. #10. Rack, 6' wide x 7' high, on 3/4-ton pickup; 8' of roadway. Good installation and utility for small vehicles and livestock.

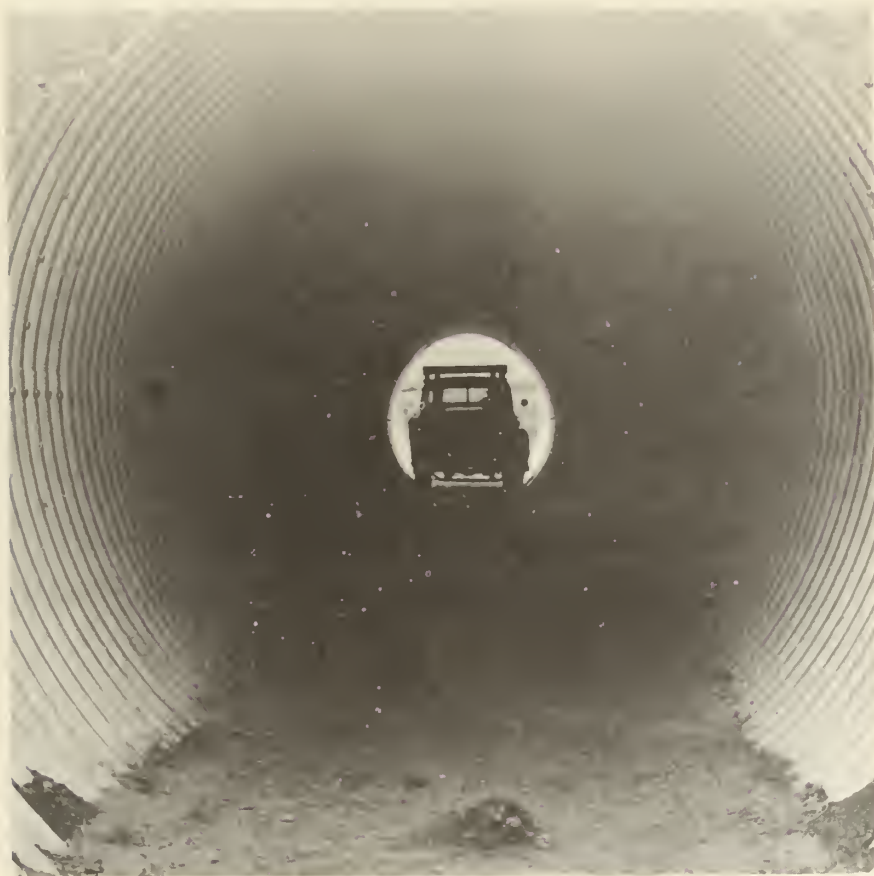
South Entrance Looking North

120" diameter x 100' long, C.M.P. Eight miles west of Three Forks on old U.S. #10. Rack, 6' wide x 7' high, on 3/4-ton pickup; 8' of roadway. Pickup returning from north. Good utility for small vehicles and livestock.

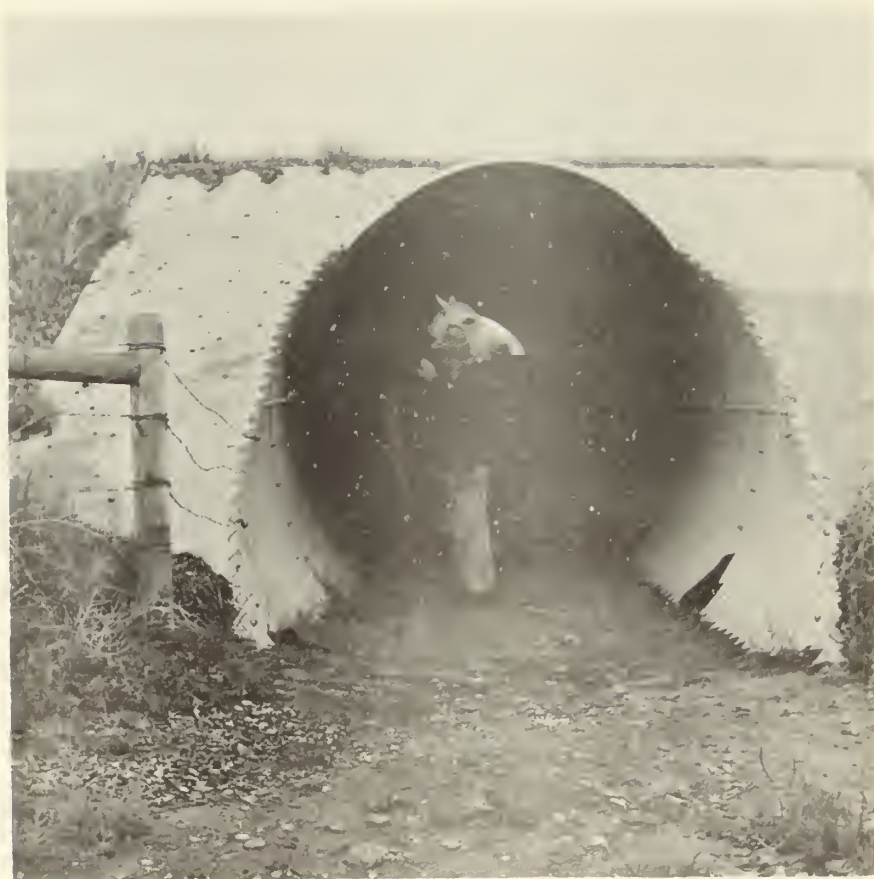
North End

120" diameter x 100' long, C.M.P. Eight miles west of Three Forks on old U.S. #10. Landowner called three horses through the underpass. Cattle use it during movement to and from summer pastures.

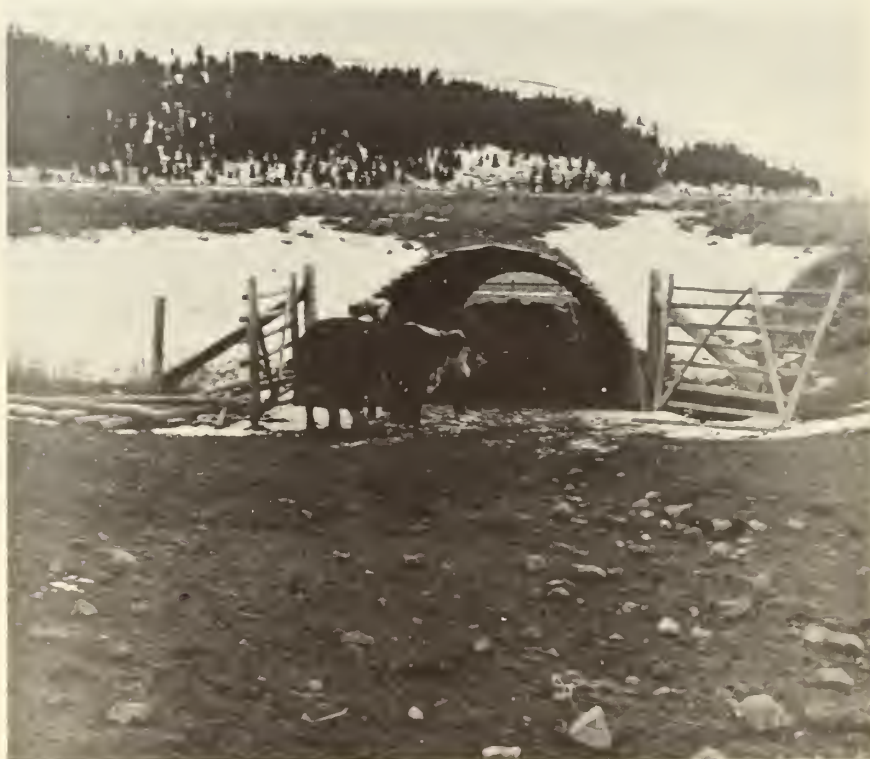
North Entrance

12'8''s x 8'7''r x 90' long, Squash C.M.P. Three miles north of Monida Pass under I-15 two-lane. Herd movement of 250 head 20 miles to winter pastures. Pipe is in low spot allowing spring runoff to silt it in. For this reason, there is only about 6 $\frac{1}{2}$ ' of clearance. High utility in fall, not so good in spring.
